Passive Building IAQ Study

2nd and Delaware Reported Air Quality Concerns

Second and Delaware

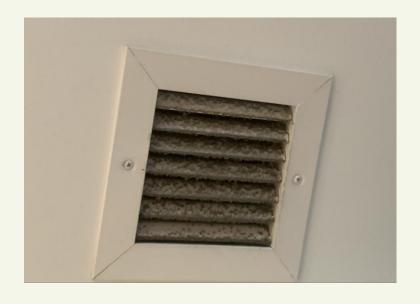
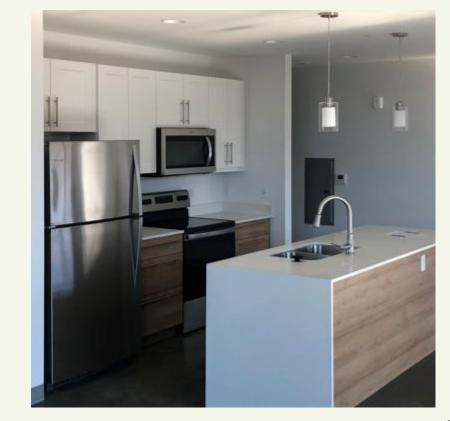
Kitchens

- Visible grease on grilles in apartments where there is a lot of cooking
- Corelates with black filters

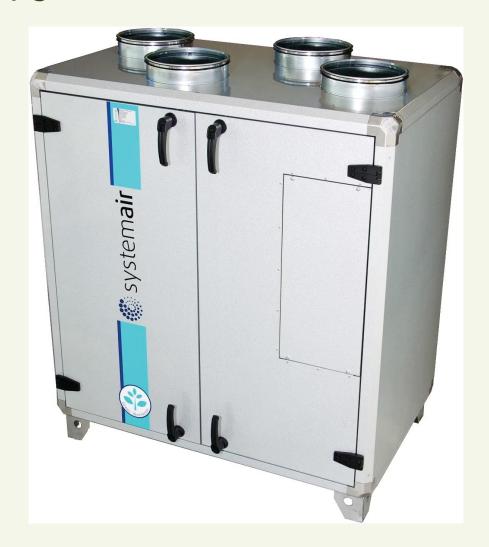
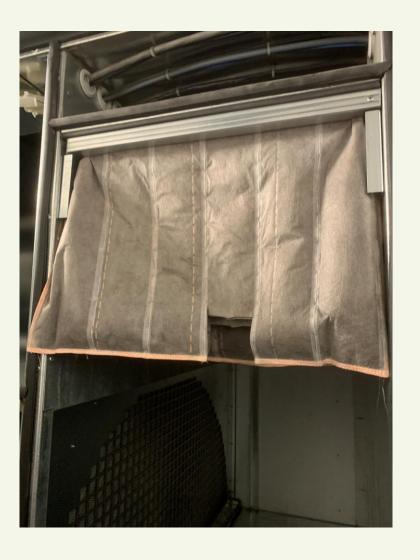
ERV Filters

- 12" Deep bag tilters changed to 8" deep
- Non-standard box dimension requires proprietary filter

- Retro-commission ERVs and check air balance
- Train staff on BAS interface and alarms
- Seek third party source for ERV bag filters
- Apartments with pets may need more frequent filter change and perhaps better filtration.
- Running HVAC fans continuously on low flow will reduce interior PM concentrations

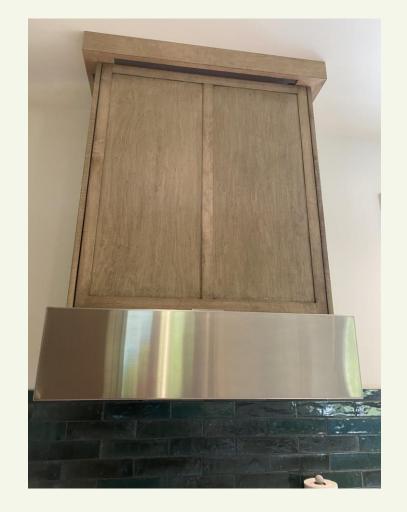
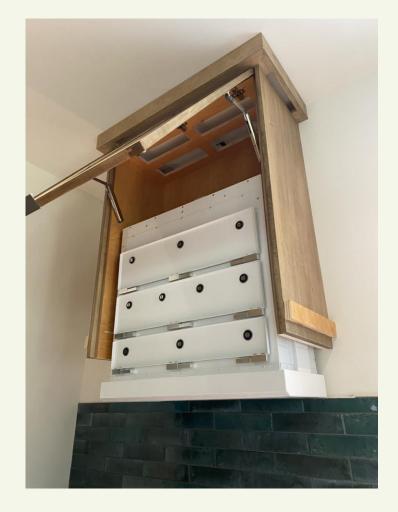
ACTIV AQ: PH-1

High efficiency filtration for recirculating hood
