# Bank Lofts

Passive House Retrofit of a Historic Rural Landmark

October 10<sup>th</sup>, 2026

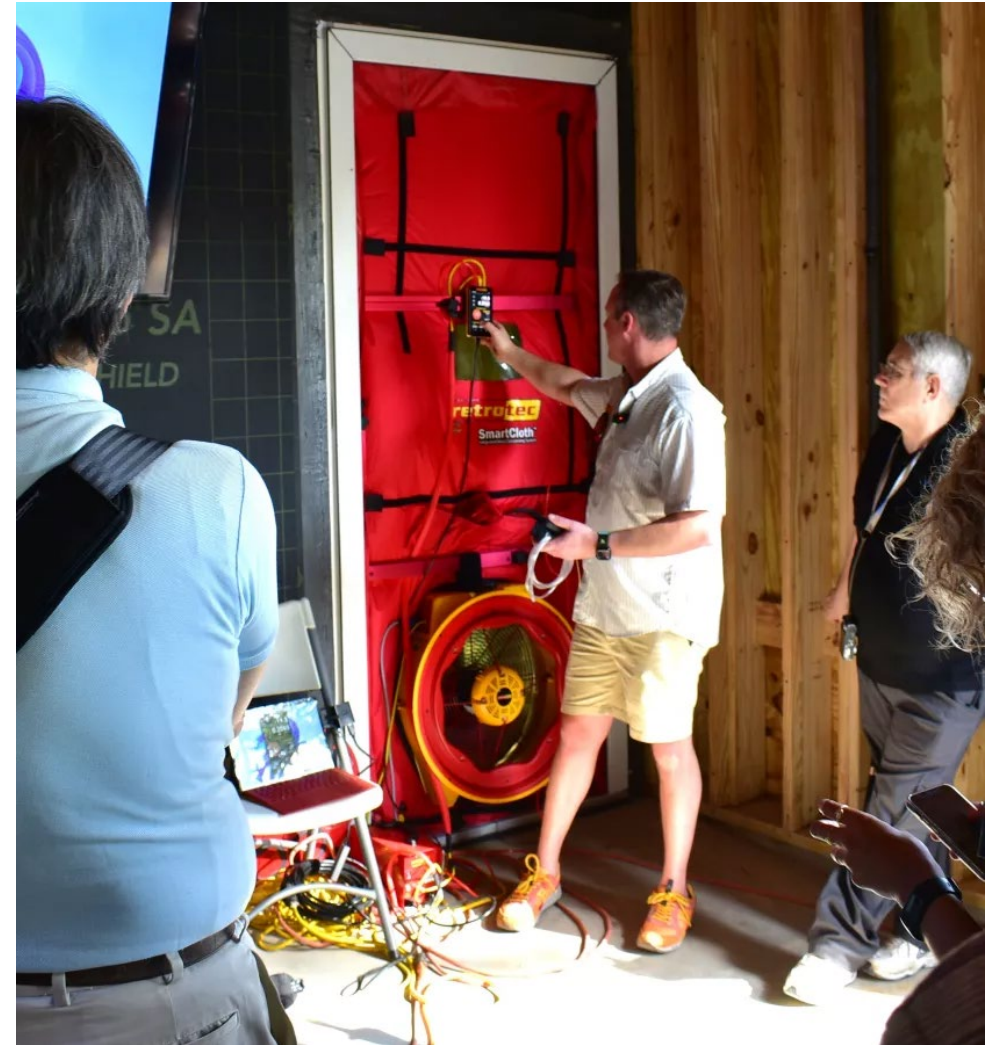
## Blower Door Test Result

Whole building air leakage – **0.06 CFM50/ft<sup>2</sup>**

Apartment unit air leakage – **0.05 CFM50/ft<sup>2</sup> to 0.08 CFM50/ft**

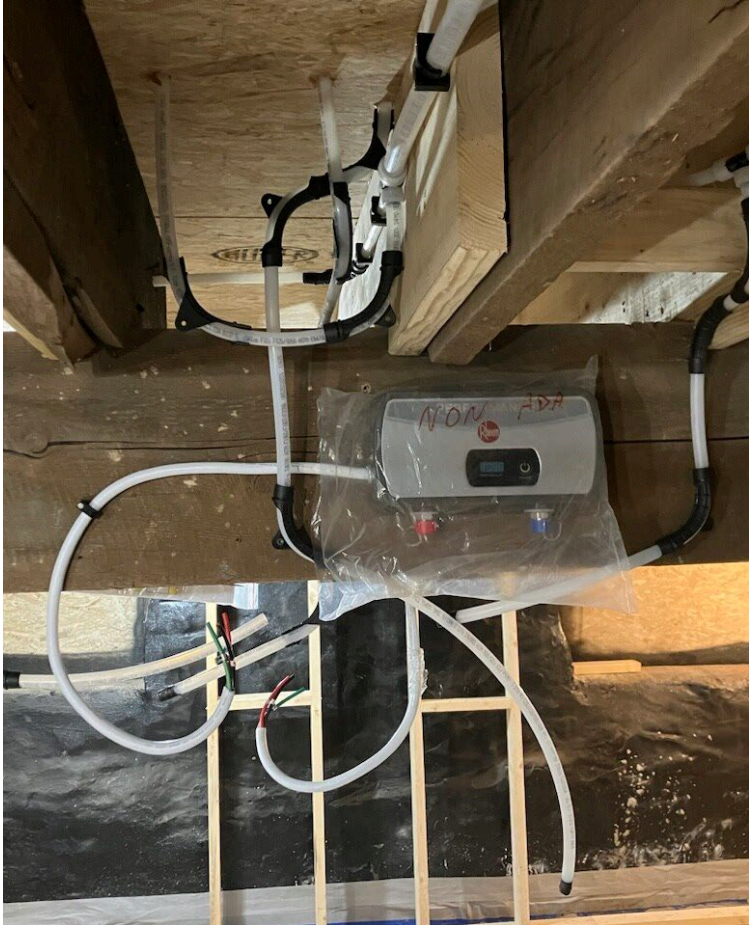
On-demand commercial bathroom water heater

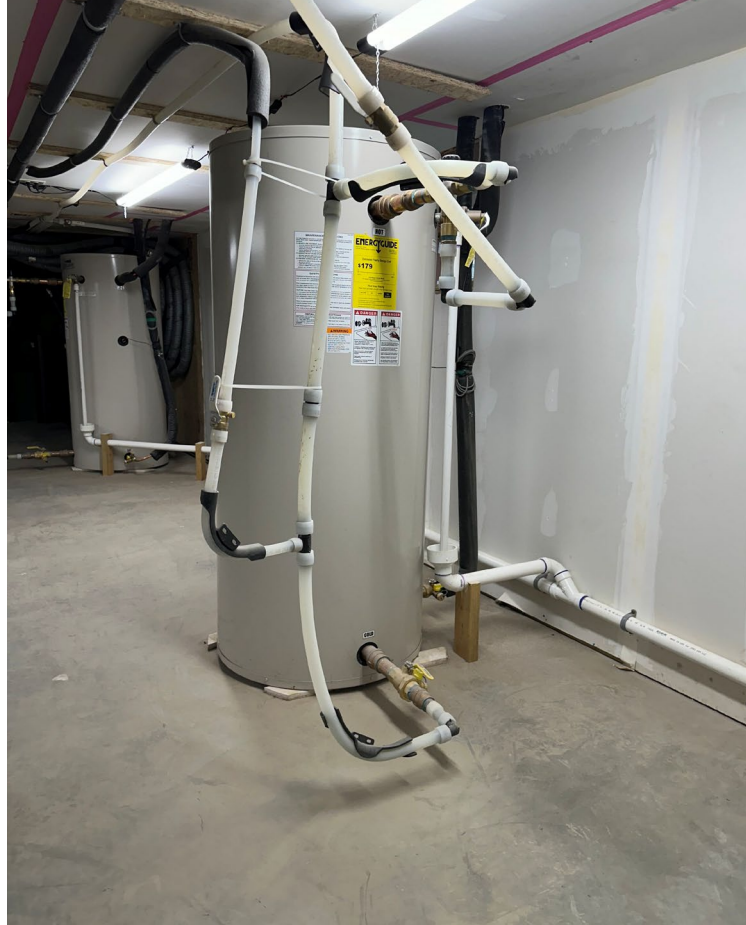
Heat pump water heaters
