At the Finish Line: How Two Affordable Passive Projects Crossed the Hardest Hurdles

2017 Passive House Design Challenge

Building Inherent Value:

Executing a Passive House

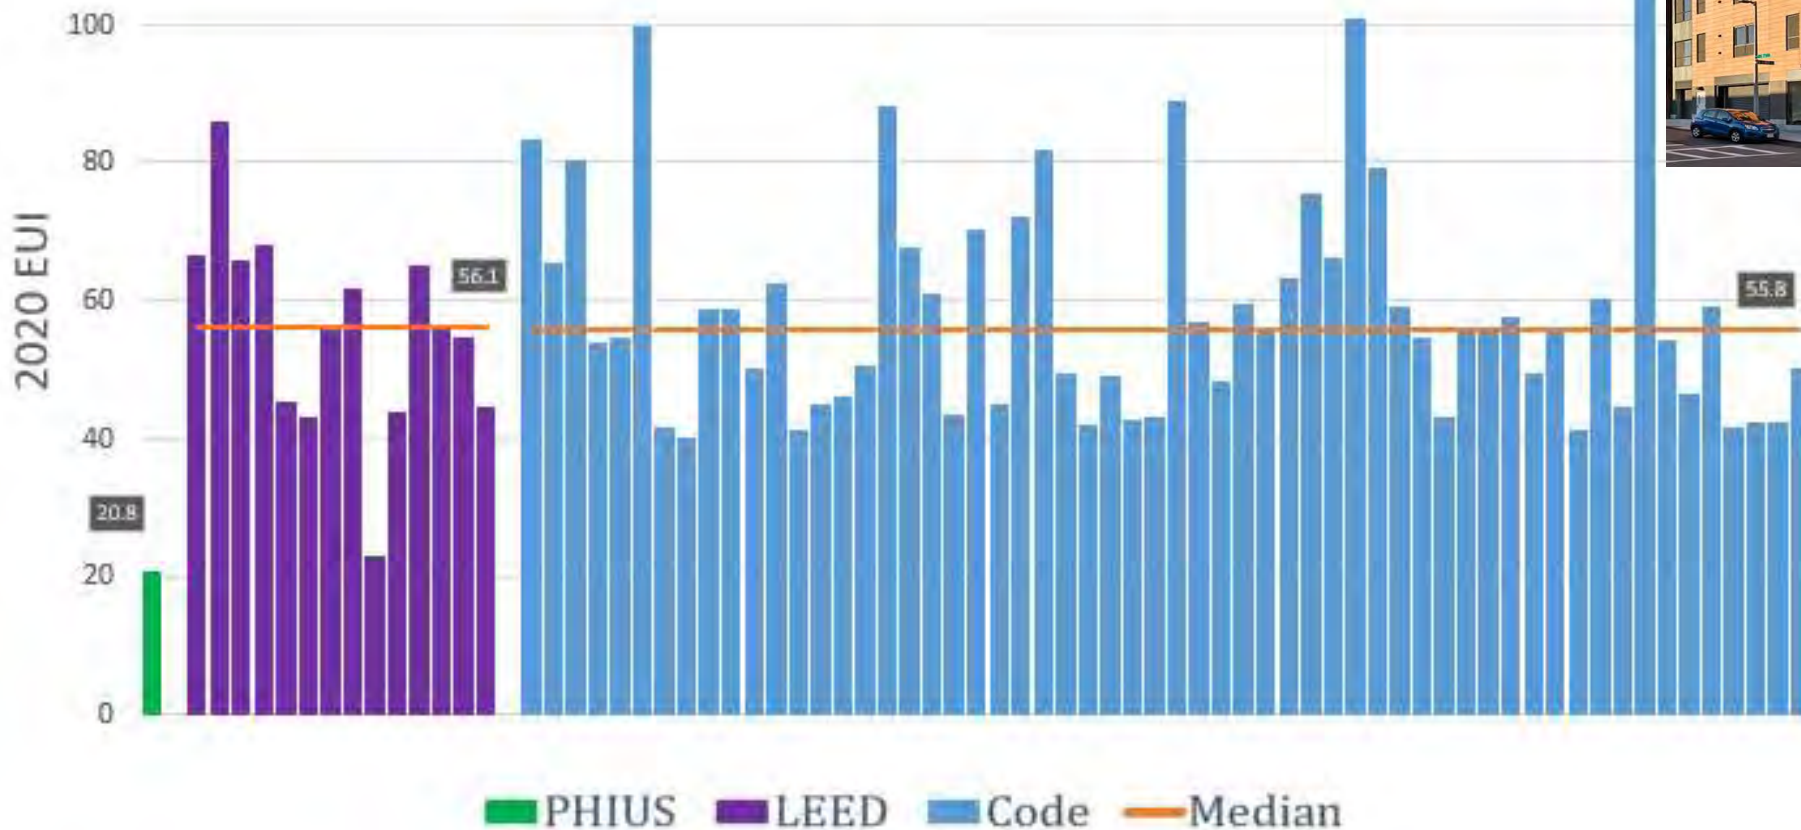
Performance: Distillery, Boston 2020

PH Uses 63% less energy per sq. ft. than median new multifamily in Boston

Data from Boston Energy Disclosure 2020 sorted for new construction multifamily built since 2010; Cross checked for LEED certification; properties with suspected lack of full building energy report are removed.

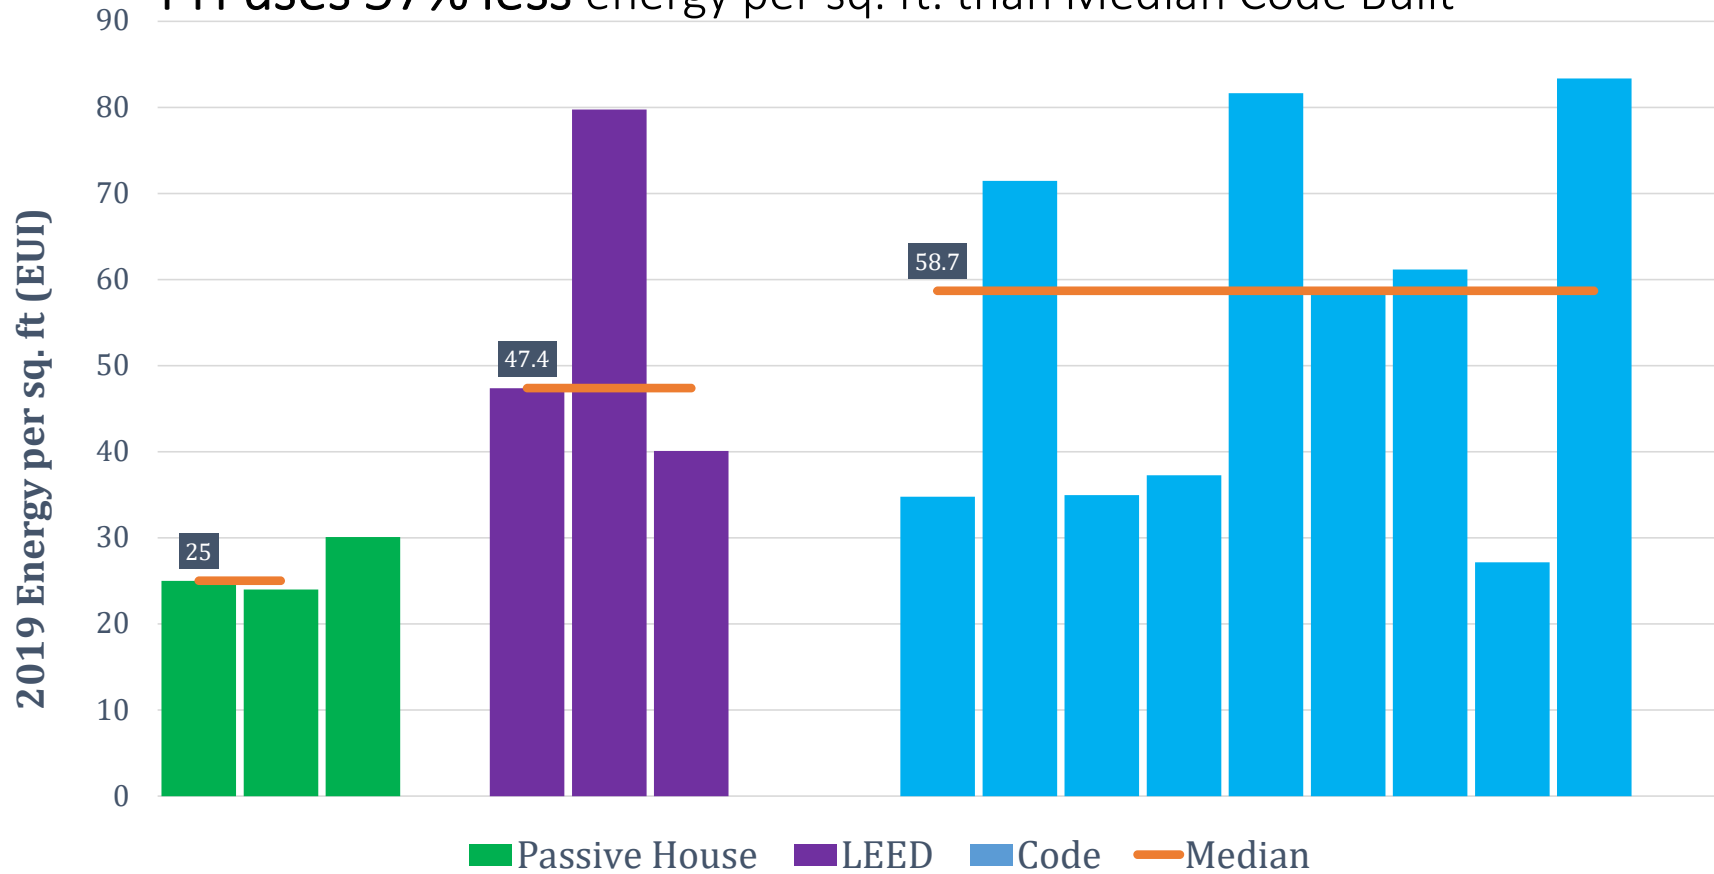
Performance: Philadelphia 2019 Affordable

PH uses 57% less energy per sq. ft. than Median Code Built

Data from Philadelphia Energy Disclosure 2019 cross checked for LIHTC multifamily; Credit to Green Building United, Katie Bartolotta

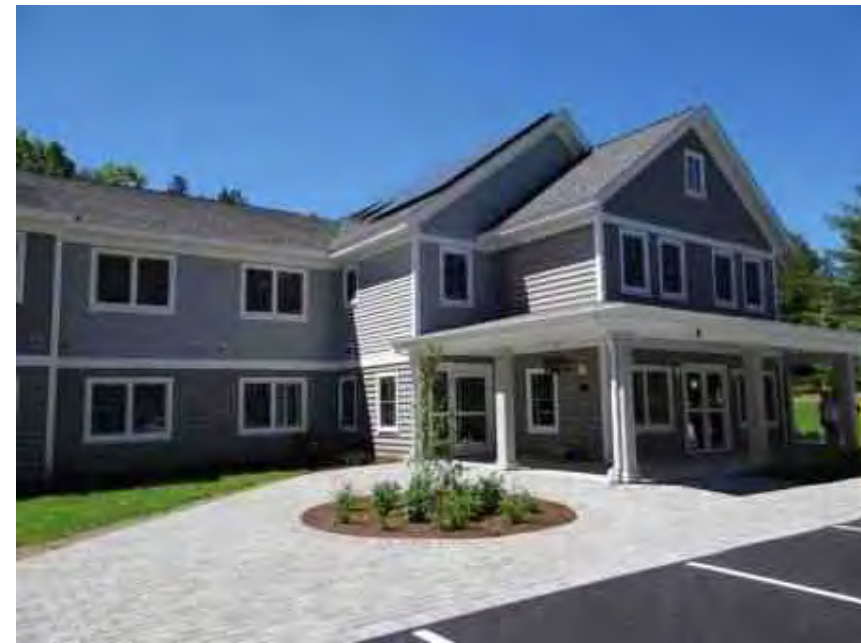
PH Performance 2019: Gilford Village Knowles III, NH

PH uses 49% less energy per sq. ft. than Gilford Village Knowles II LEED built 2008
(same building, different standard)

Graphic representation of study by Resilient Building Group (2020 Report of average 3 year energy usage data ending in 2019)

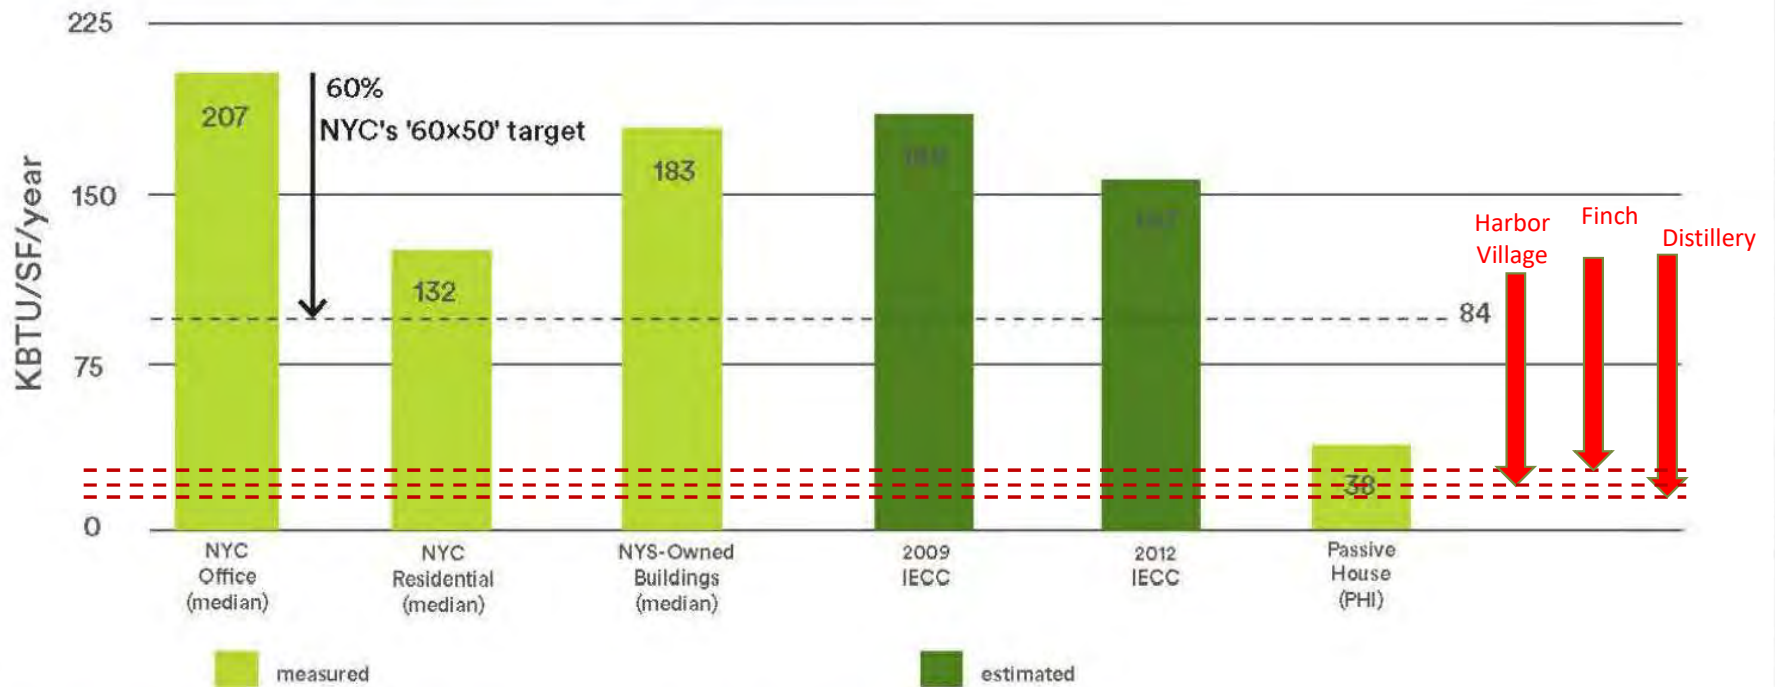
Figure 2: Source Energy Use Intensity (EUI) Comparison

Source: New York City Local Law 84 Benchmarking Report, 2013

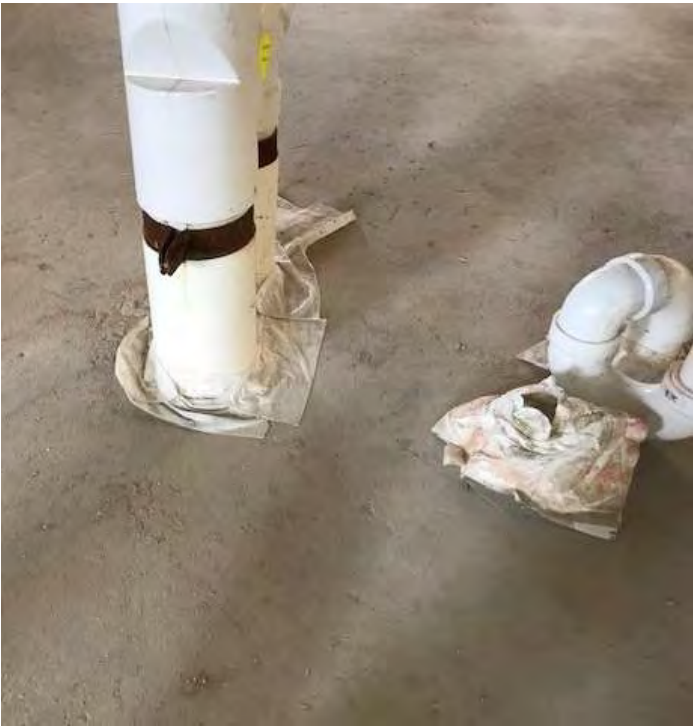
First Try – Not Approved

Craft: Pipe/Penetration Airtightness

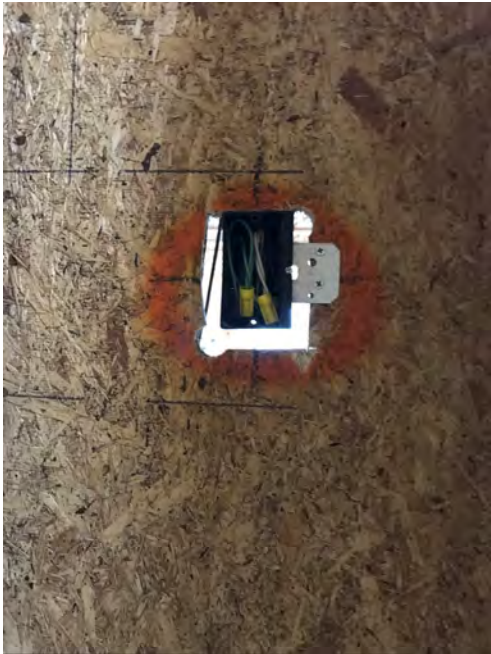
Not Approved

CRAFT– Electrician

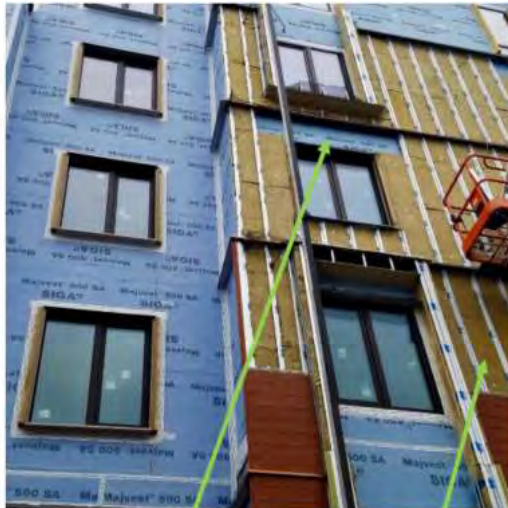
Windows
Airtightness
Duct Leakage
Thermal Bridging/Gaps

| .6 ACH₅₀ | 2611 CFM₅₀ |
| <u>DUCLOS METHOD RECOMENDATIONS</u> | |
| Stage #1 Test (envelope no windows & Doors) | 652.75 CFM ₅₀ |
| Stage #2 Test (windows & doors) | 1552.75 CFM ₅₀ |
| Stage #3 Test (MEP penetrations) | 2219.35 CFM ₅₀ |

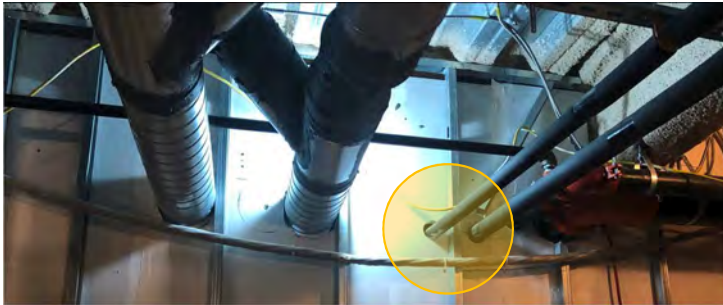
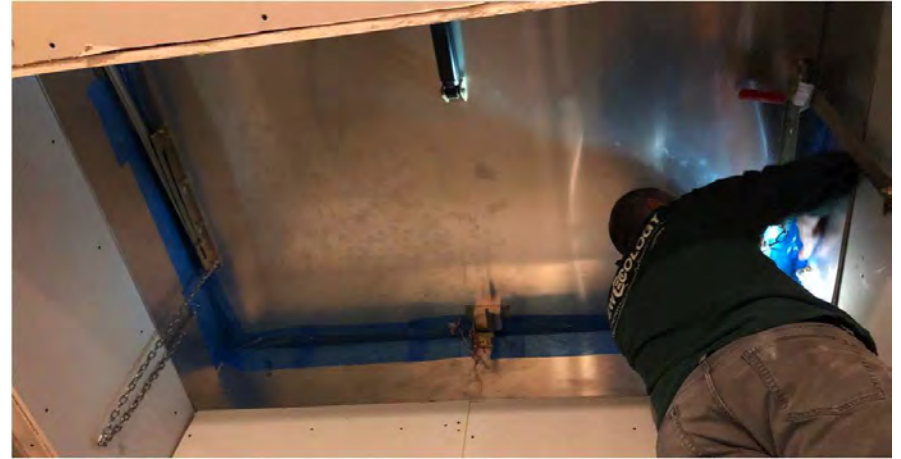
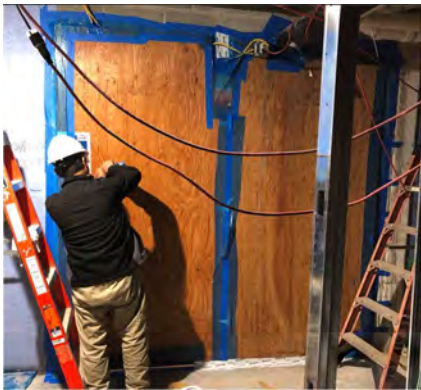
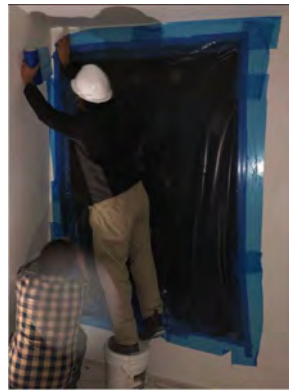
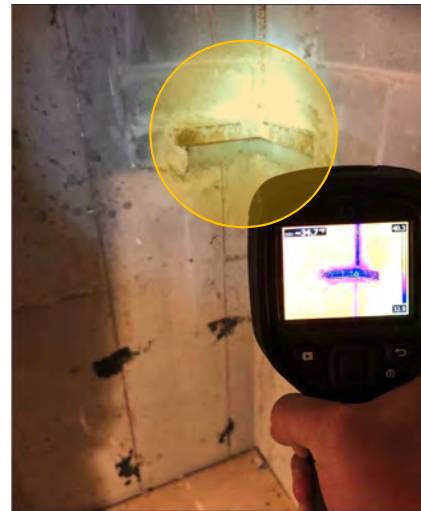
2/26/2021 – Midpoint 1

WBBD Results – Midpoint to Final

| Date | CFM50 (depress.) | CFM50 (press.) | CFM50 (avg.) | ACH50 |
|---|---|---|---|---|
| 2/26/21 | 5,486 | - | - | 1.44 |

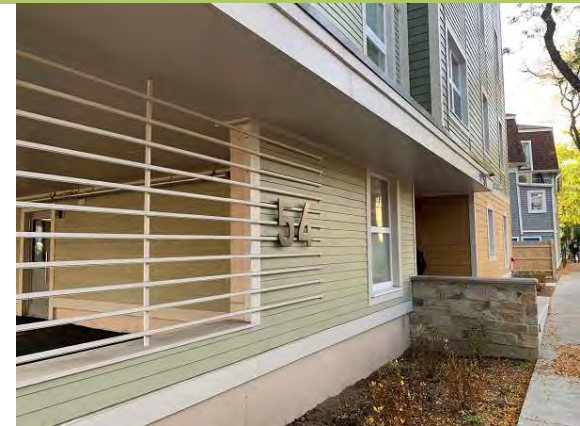
SQW – Project Summary

- Owner/Developer: Just-A-Start
- 14 affordable family units
- PHIUS+ 2015
- iCFA: 13,400 ft²
- Opening Fall 2021

| | Target | Modeled |
|---|---|---|
| Air Tightness | 0.05 cfm/ft ² (971 cfm) | 653 cfm (0.27 ACH50) |

3rd tightest MF building in US, excluding THs

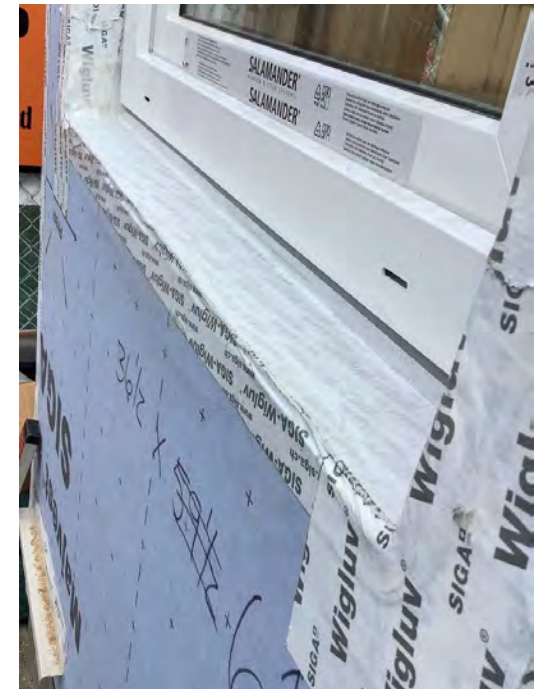
SQW – Envelope

- Double studded wall
 - 2x6 structure; 1" space; 2x4 interior wall
 - Staggered studs, 24" O.C. as allowed
 - 3" CCSF inc. studs + 7" Cellulose
 - Siga AWB

- Windows
 - Triple Pane; clips
 - Insulated Headers
 - Siga Wigluv flashing

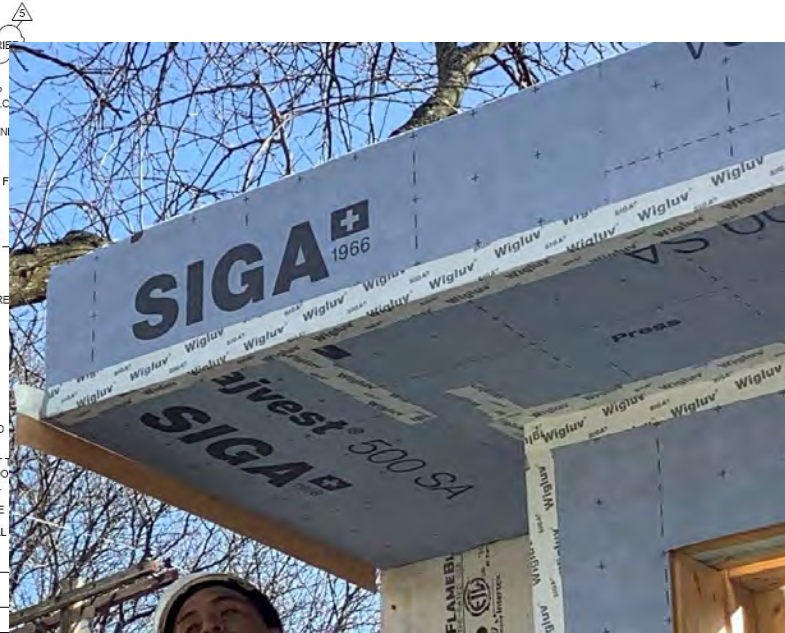
SQW – Envelope

Roof:

- 2" min Polyiso above roof deck
- 20" Truss depth with 4" of CCSF
- 16" cellulose

Foundation/Slab

- 5" EPS sub-slab insulation
- 15 mil Steggo Wrap VB taped to Siga WRB
- 2x2" EPS foundation

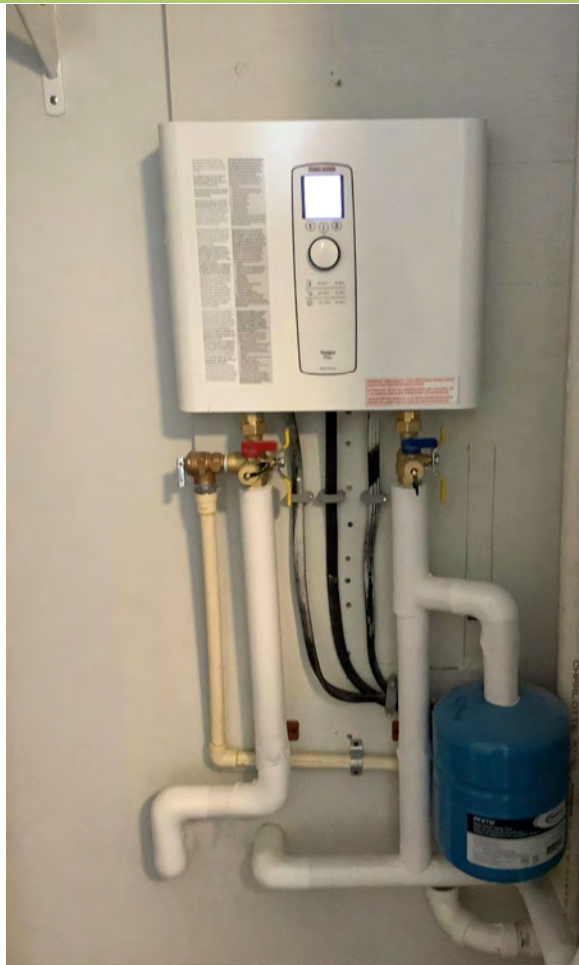
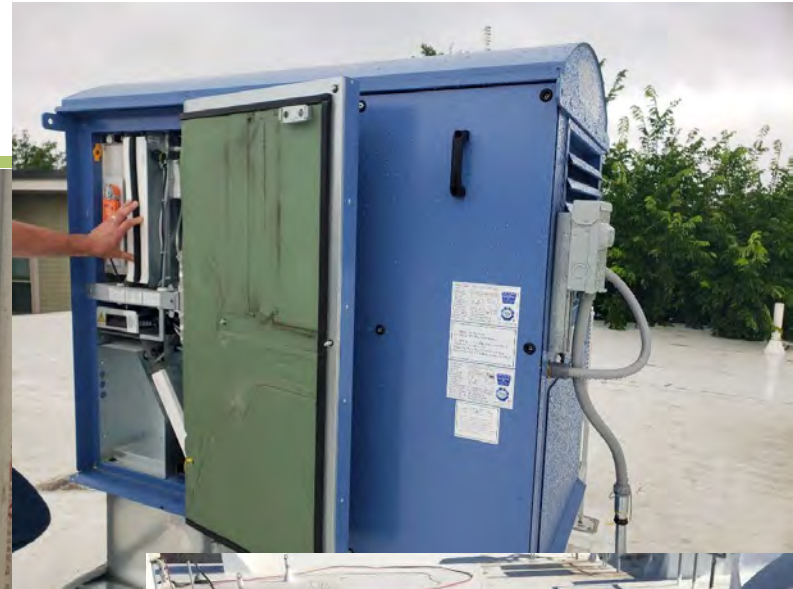
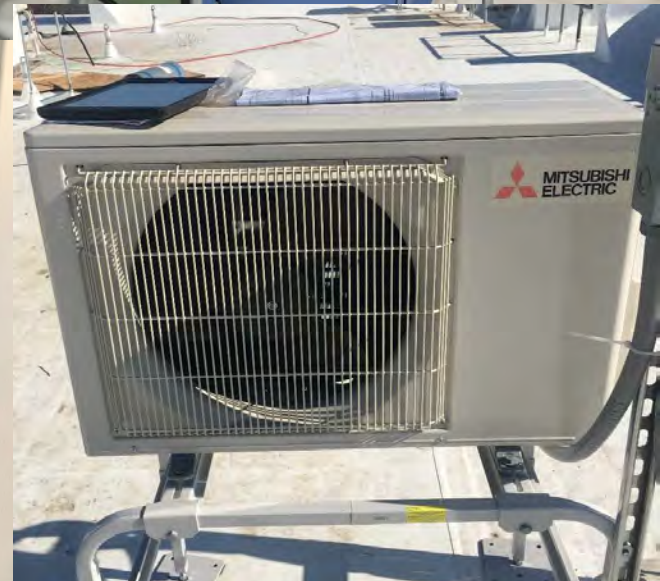
SQW – Systems

Ventilation:

- Ventacity VS1000;
- 82% Eff; 0.61 W/CFM
- 850 CFM

DHW:

- Instantaneous Electric
- Stiebel Eltron

Heating/Cooling

- Mitsubishi SUZ-KA HPs

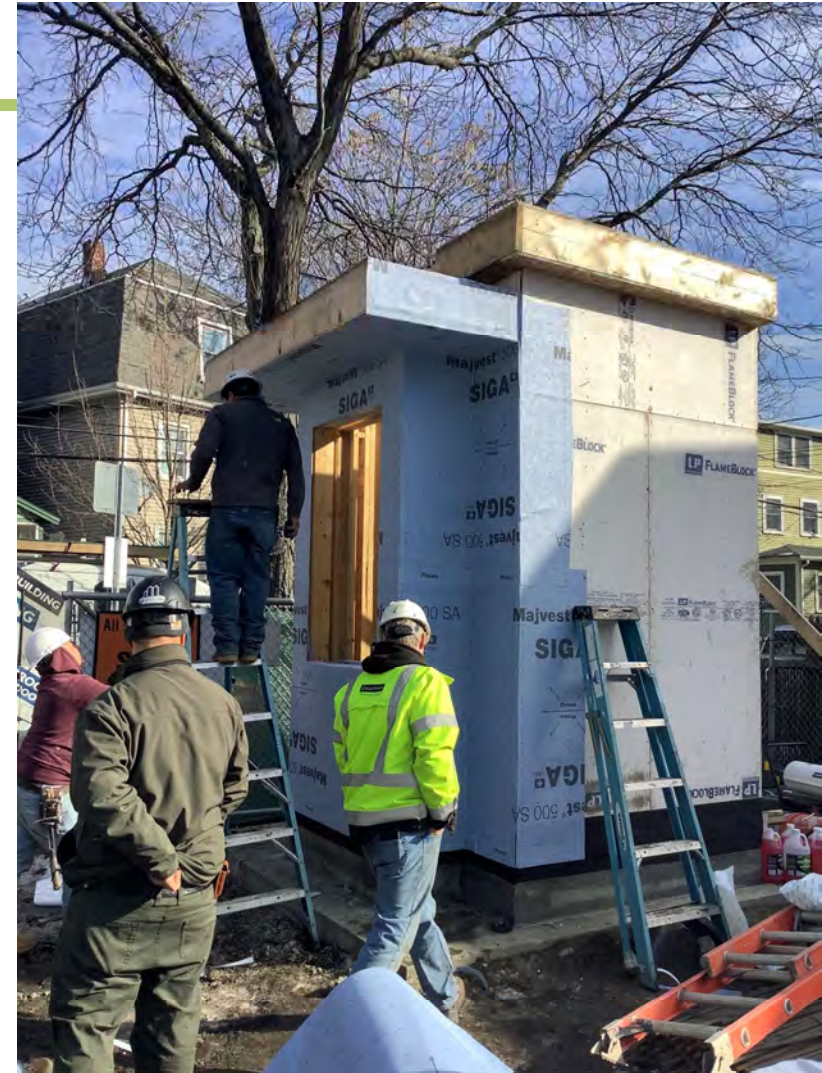
SQW – Process – Mock-Up

Dedicated Mock-Up

- Most important stage of construction Assume multiple visits from CPHC and BECx
- Bring window and AWB manufacturer on site
- Identify critical details and transitions:
 - Foundation/slab/wall
 - Wall: AWB/insulation, inside/outside corners
 - Window flashing/install
 - Wall/Roof transition
 - MEP Penetrations
 - Doors –Leave up until building reaches the same level of completion
- COLLABORATE

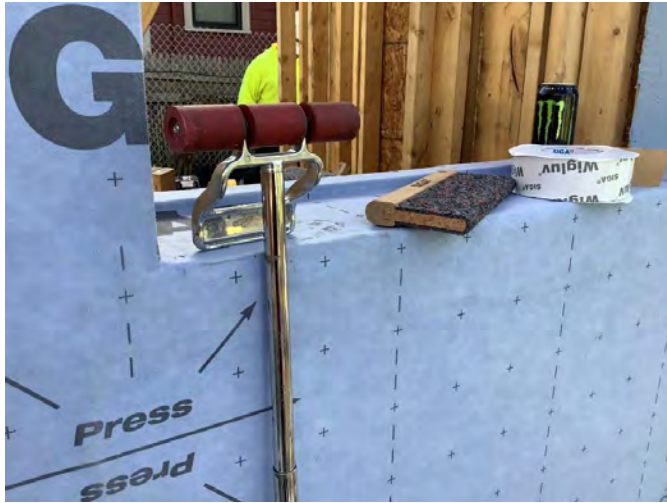
Require proper tools

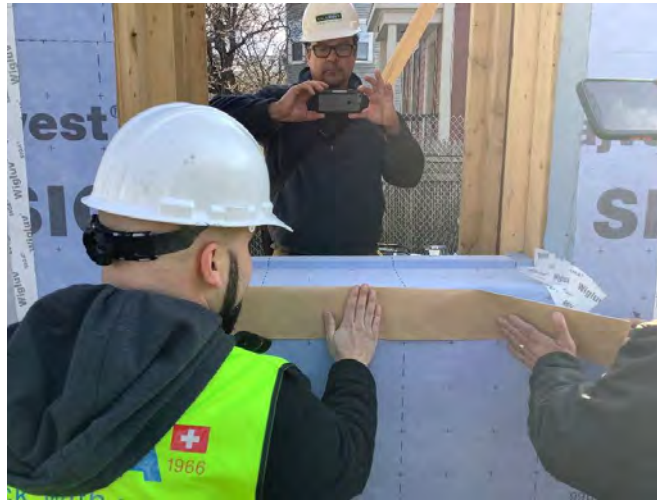
Document each step

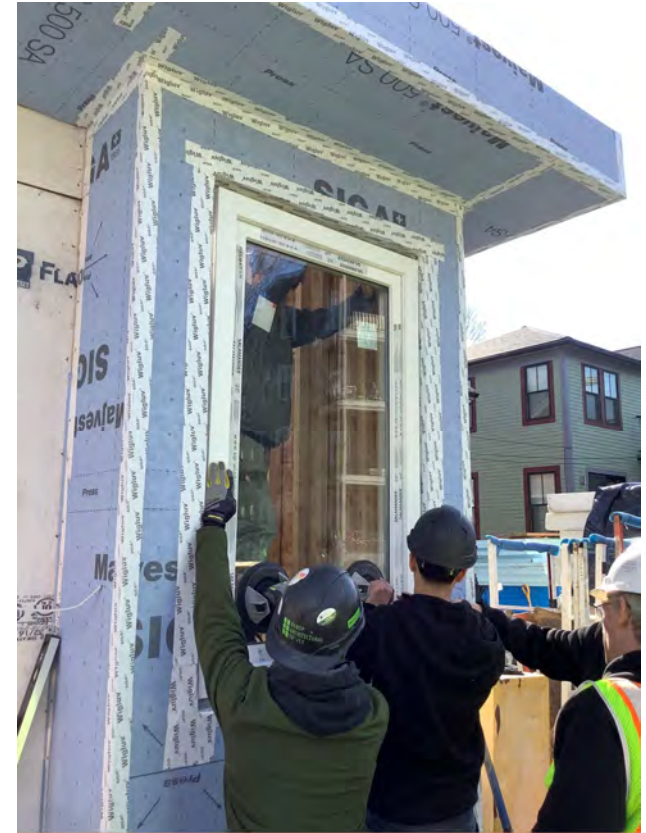
Involve all related subs

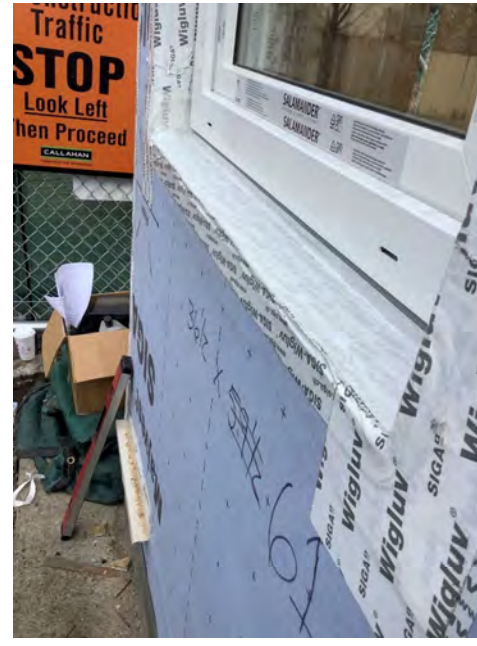
Finalize and confirm approach

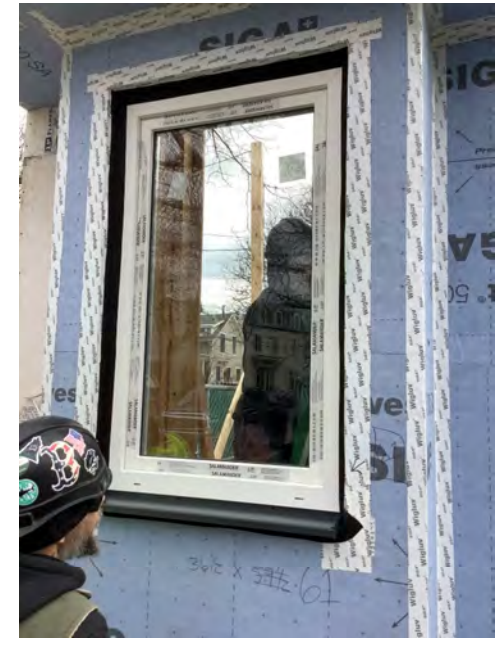
Leave up until installed in situ

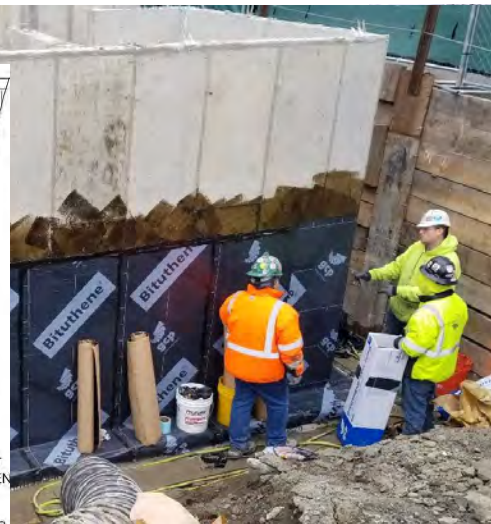
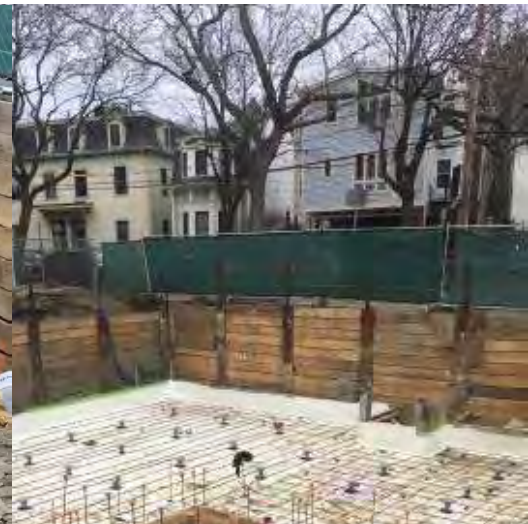
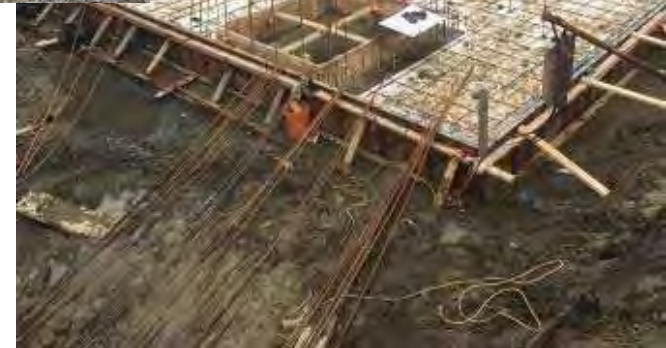
SQW – Challenges and Solutions

Detail created after design – PREPRUFE membrane and mat slab required due to high water table.

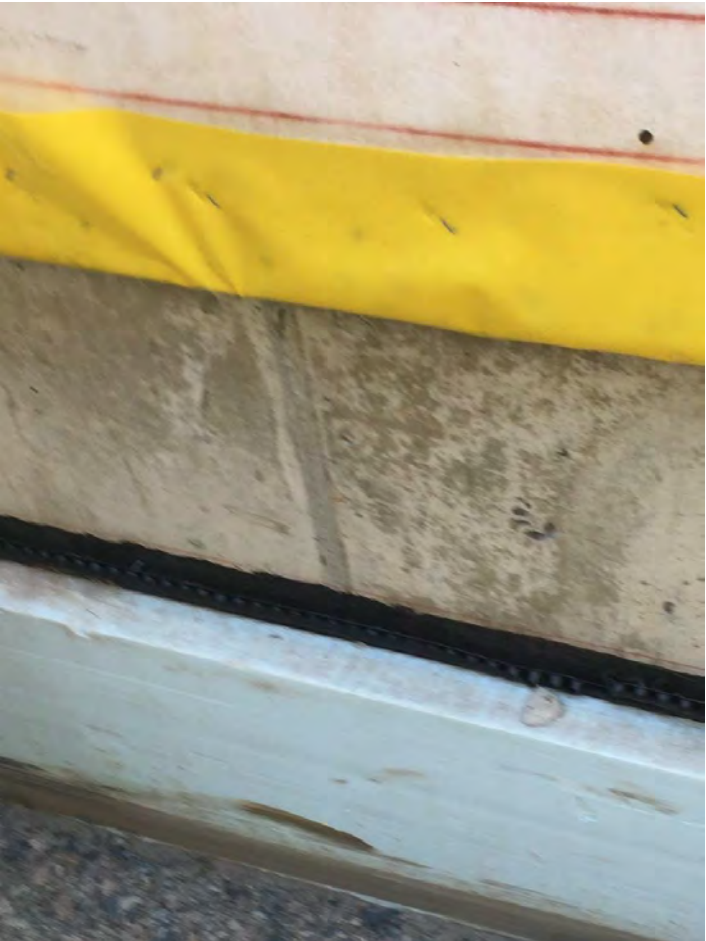
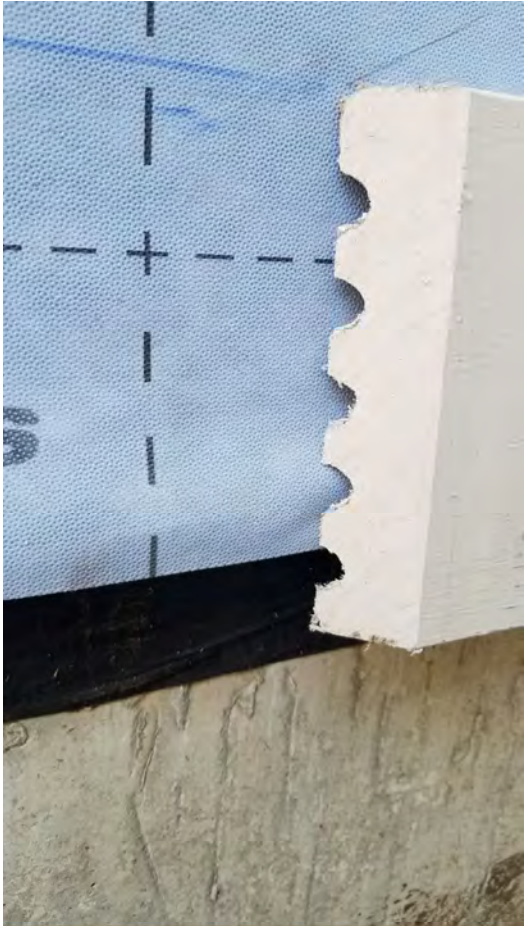
SQW – Challenges and Solutions

Awkward transition for AWB

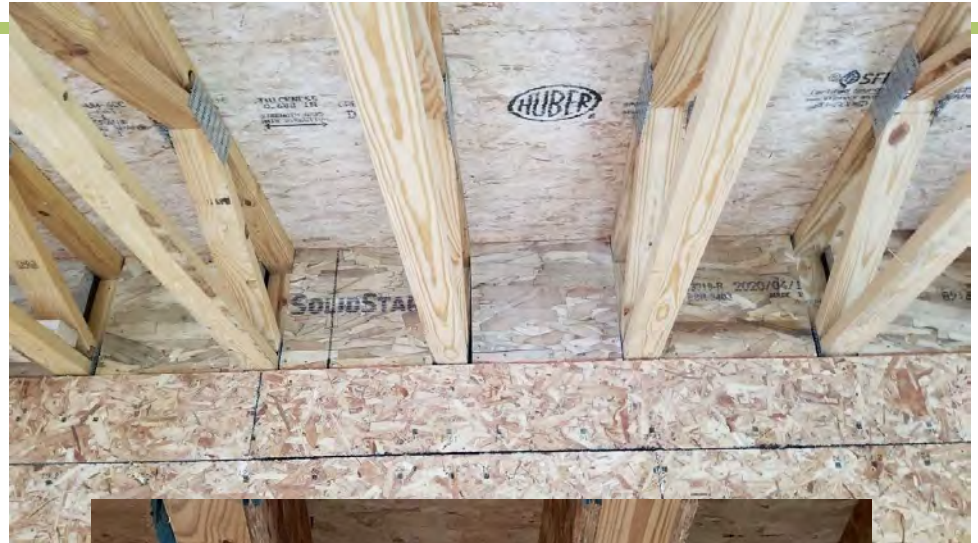
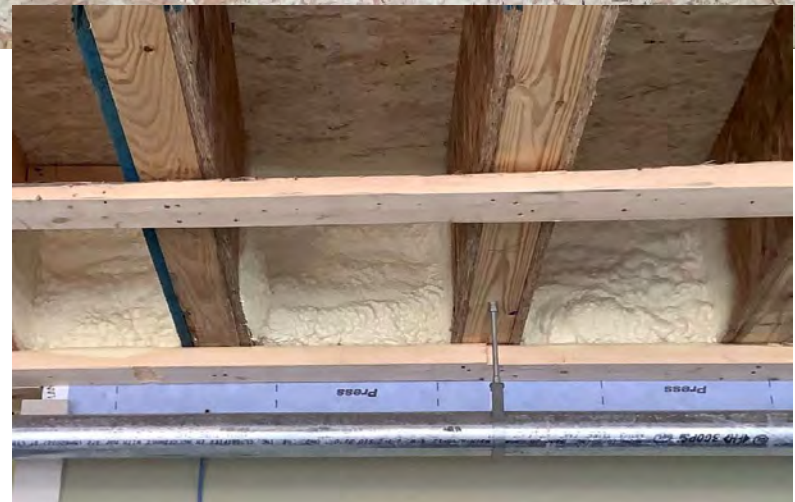
A-9 DETAIL AT EXT. ENTRY DOOR HEAD

1 1/2" = 1'-0"

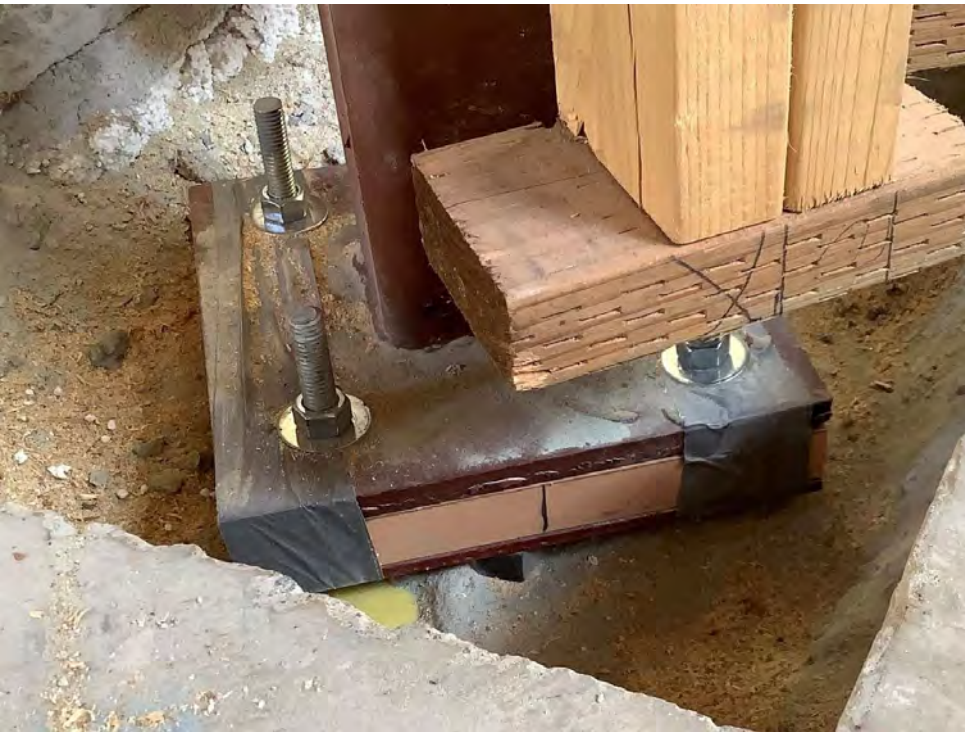
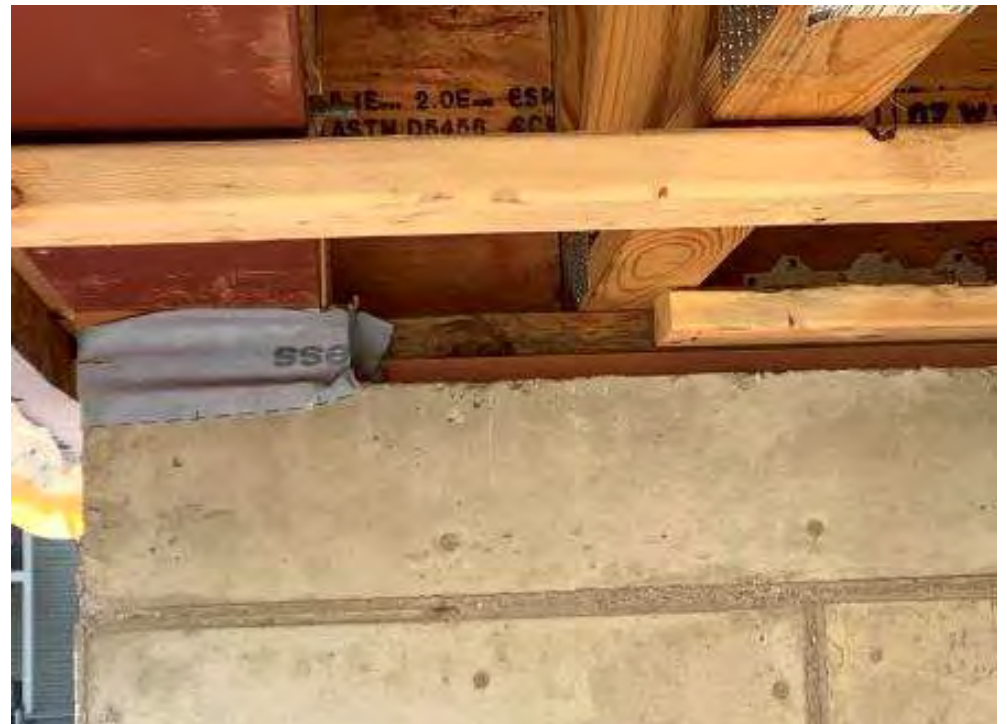
SQW – Challenges and Solutions

Thermal Insulating Pads

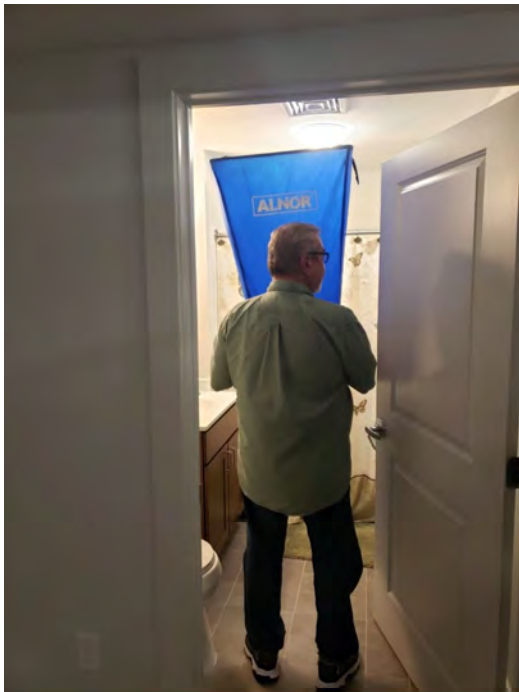
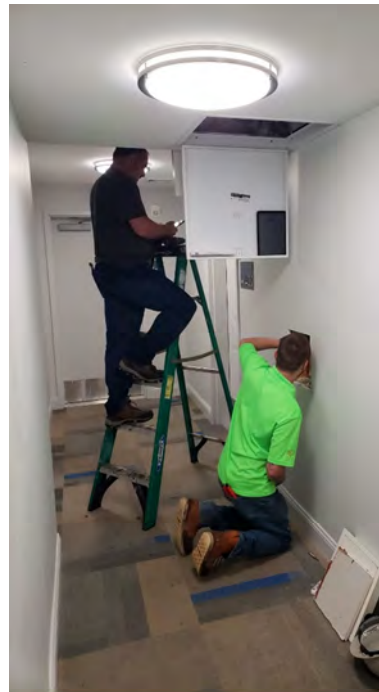
SQW – Challenges and Solutions

Ventilation testing ... and failure.

Squirrelwood Bldg L Ventilation

| | SUPPLY | | | EXHAUST | | |
|---|---|---|---|---|---|---|
| TOTAL | 850 | 724 | 15% | 850 | 845 | 1% |

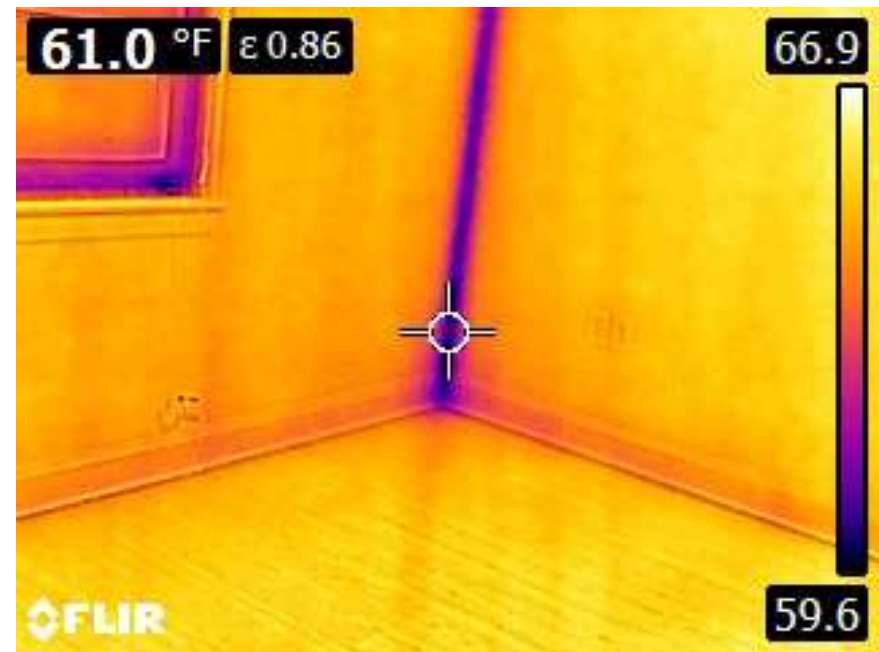
SQW – Challenges and Solutions

Even with open corner framing, insulation had to be fixed in some locations
- Continuous QC

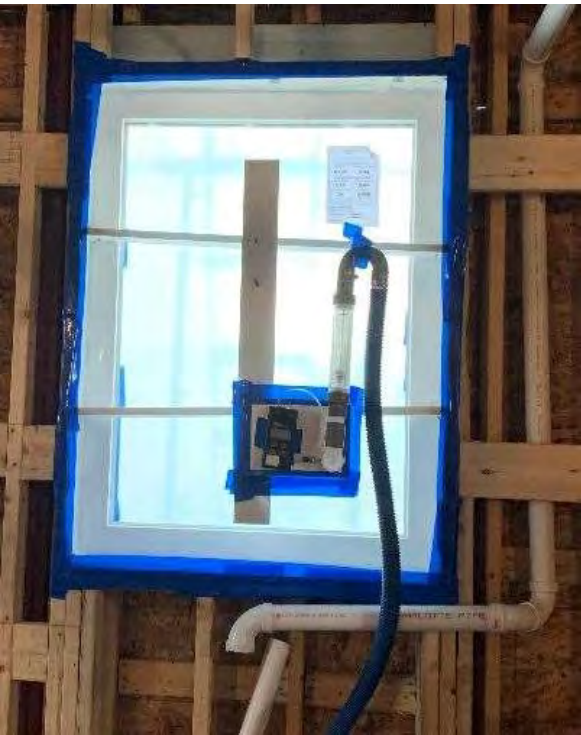
SQW – Challenges and Solutions

Window testing – in situ and early
- Consider test on mock-up

Air Infiltration Tests, ASTM E783

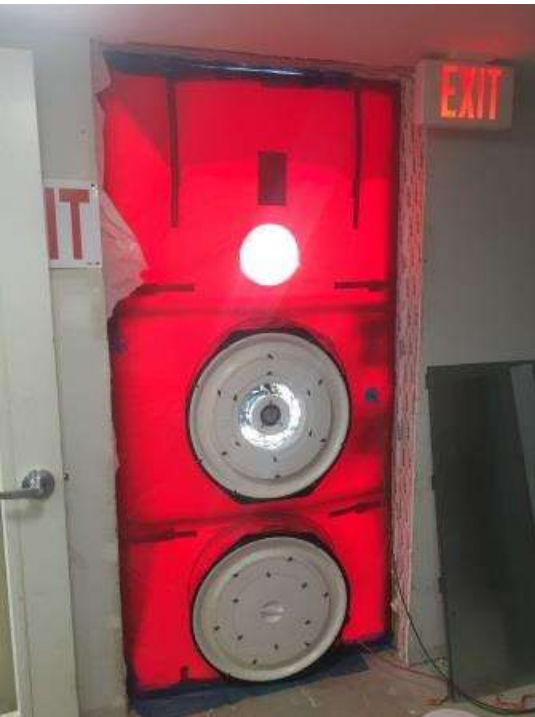
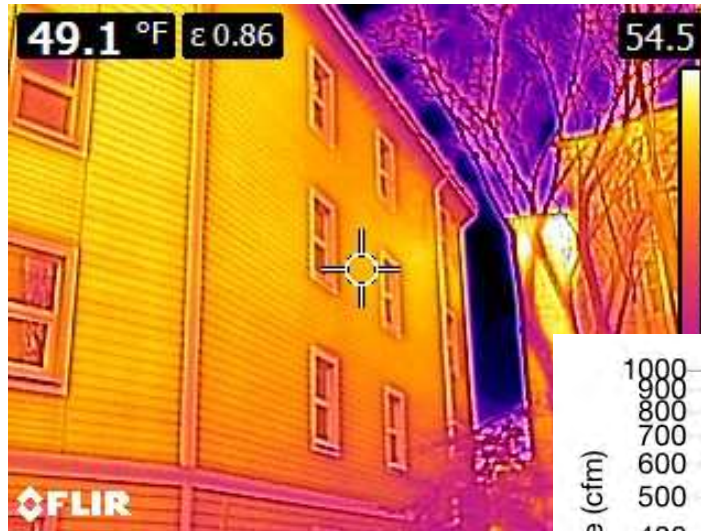
SQW – Challenges and Solutions

Envelope Testing – Passed – first attempt.
