# Phius Murder Mystery:

**An Interactive Whodunit Game Focused on Uncovering and Solving  
Issues That Can “Kill” Phius Certification**

# The Case of the Phius Project That Almost Didn't Make It

*One fictional/composite 13-story multifamily brick project targeting Phius certification.*

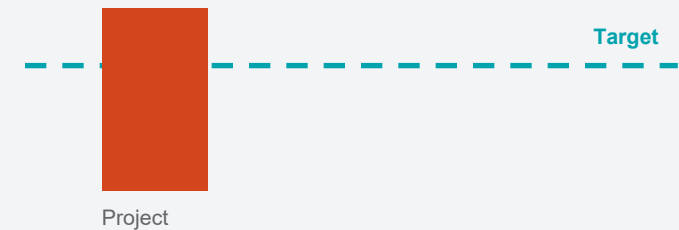
SOURCE ENERGY vs. TARGET

*Source energy repeatedly exceeds the target.*

**The miss:** the project is not meeting the source-energy target — but the model does not yet tell us why.

**Stakes:** source-energy compliance is repeatedly missed.

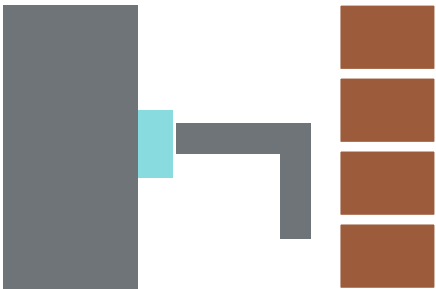
INTENDED · ISOLATED ATTACHMENT

Thermal-break pad — path interrupted

- Requirement: brick attachments are thermally broken.
- Architectural detail: thermal-break strategy appears intact.

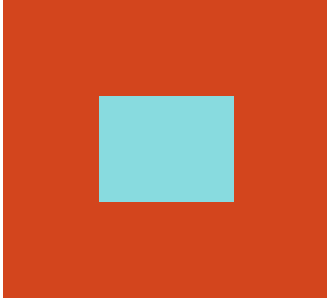
SHOP DRAWING (SUBMITTED)

Thicker frame

**The clue:** the shop drawing showed a thicker frame than the Plius datasheet and model.

**Risk:** the performance decrease threatened the project's compliance margin.
